Forest UPDATE Certification

Canadian Forest Products – Prince George Region Woodlands Operations

August 2007

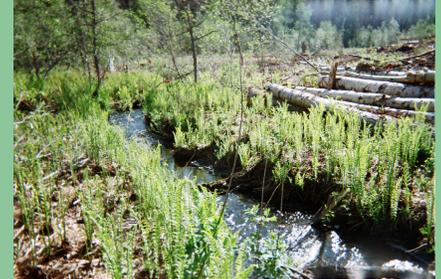
Field example of an effectively deactivated (pulled) bridge that promoted the maintenance of stream bank integrity and the minimization of sedimentation.

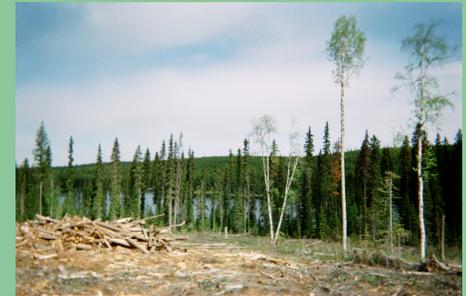
Field example of a well planned and implemented riparian buffer maintained along an L1 lake.

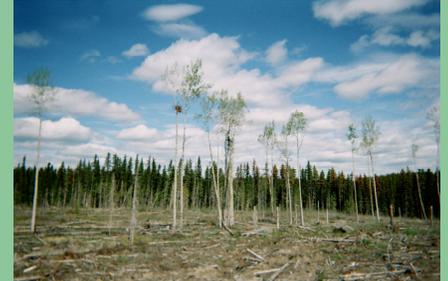
The operation was doing a good job of retaining on-block trees where feasible in an effort of maintaining biodiversity or (as in this case observed in the field) maintaining wildlife features (i.e., stick nest).

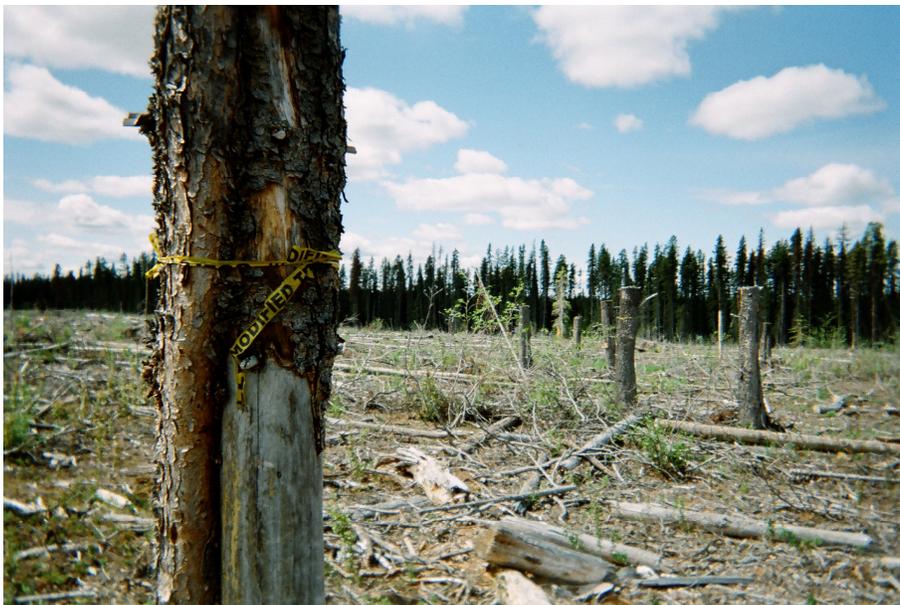
There were numerous examples of culturally modified trees observed in the field that were appropriately assessed, mapped, marked and in some cases protected (e.g., incorporated into wildlife tree patches) or stubbed (as in the photo) by the operation.
